DEPARTMENT OF TRANSPORTATION

Contract #: 04-0120F4Cty: SF/ALA Rte: 80 PM: 13.2/13.9File #: 69.28**WELDING INSPECTION REPORT****Resident Engineer:** Pursell, Gary**Address:** 333 Burma Road**City:** Oakland, CA 94607**Report No:** WIR-001393**Date Inspected:** 19-Jan-2008**Project Name:** SAS Superstructure**OSM Arrival Time:** 700**Prime Contractor:** American Bridge/Fluor Enterprises, a JV**OSM Departure Time:** 1530**Contractor:** Zhenhua Port Machinery Company, Ltd (ZPMC), Changxing Island **Location:** Shanghai, China

Bridge No: 34-0006**Component:** Tower Mock-ups and OBG**Summary of Items Observed:**

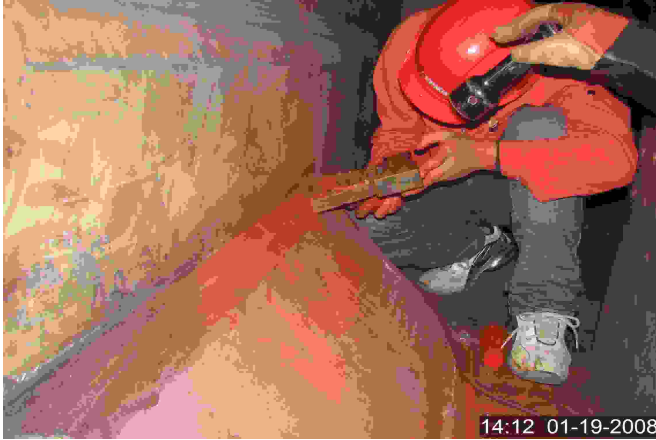
The Quality Assurance Inspector observed magnetic particle technician Lai Xin Xin performing magnetic particle testing to the corner stiffeners partial joint penetration weld. In addition Mr. Lai tested the runoff area of the complete joint penetration welds on skins A and B. Mr. Lai marked the area for repair and it was immediately removed by the grinding process. Mr. Lai reexamined the area and relayed the indication was no longer present. Below is a digital photograph illustrating the magnetic particle examination in progress.
